# Armouring a vehicle? We've re-invented the wheel!

## The Tyron R4

## ALL TERRAIN RUNFLAT (ATR) (Patent Pending)

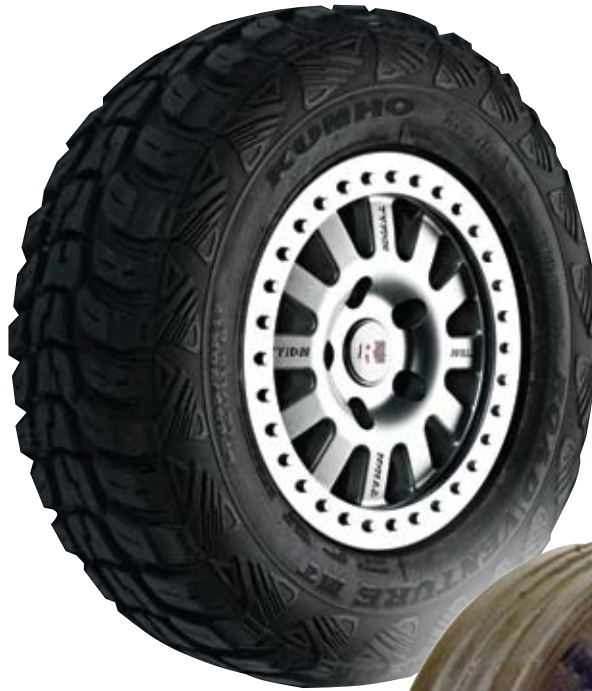
Introducing the unique R4 heavy duty wheel for armoured cars, 4 x 4 and cash carrying vehicles. This super strong alloy wheel, with a load rating of 1600Kg incorporates an ingenious beadlock design. This makes installation of the runflat safer and changing tyres can be easily carried out without the risk of damaging the tyre bead...  
... unlike other extended runflat systems!

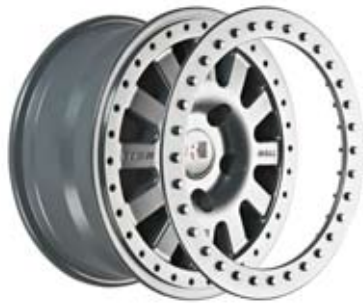
LEFT: Special beadlock retention ring dramatically increases runflat performance

Inside our new R4 wheel sits the world's only bullet-proof, multi-piece rubber with steel re-inforcement runflat. Invented by Tyron, it creates a double beadlock with the R4 wheel so it will outperform ALL other runflat systems.

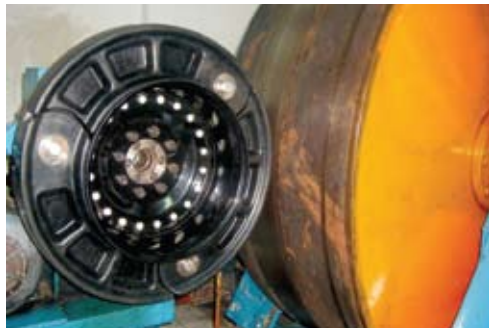
Setting up Tyron ATR for testing on a rolling road

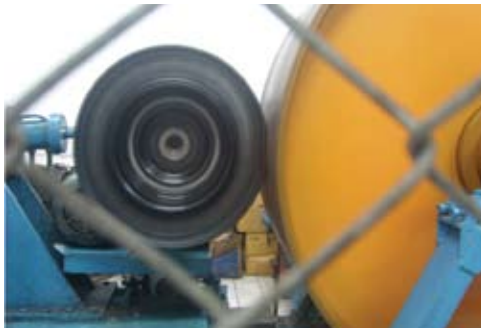
Tyron ATR undergoing load and speed testing

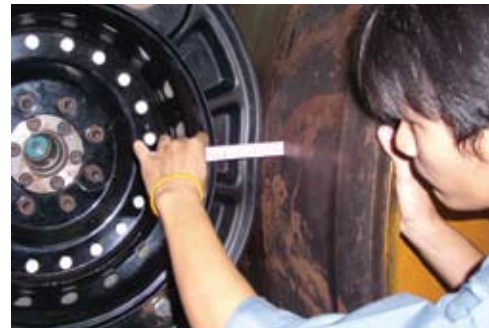
Measuring unique load deflection characteristics

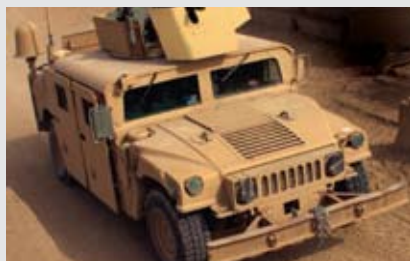
Name: Tyron ATR  
Installation: Three-piece inter-connective; field mountable, field serviceable  
Material: Rubber Runflat with steel backbone  
Load Range: Designed for Load Range D. E and HMMWV Trailer (heavy payload spec)  
Remark: Super duty, long range Runflat capability

4: Remarks and observations: The Tyron ATR met and exceeded stated performance requirements currently in place with the HMMWV and GMV programs (30 mph/30 miles). Additionally, the Tyron ATR met industry performance claims of 50 mph and 60 mph. The only visible and noticeable factors were smoking from the valve stems when driving above 30 mph as well as degradation in vehicle power performance. This degradation can be attributed to the four tyres being flat and the vehicle driving on all four Runflats. The degradation was characterized by a loss in horsepower demonstrated by reduced top end speed and rate of acceleration. Upon removal of the tyre, mechanics and operators inspected the condition of the Runflat and recognized no appreciable damage to the Runflat. They were able to disassemble and reassemble the Runflat with ease and without any special tools. The Runflats were remounted along with new tyres for further use.

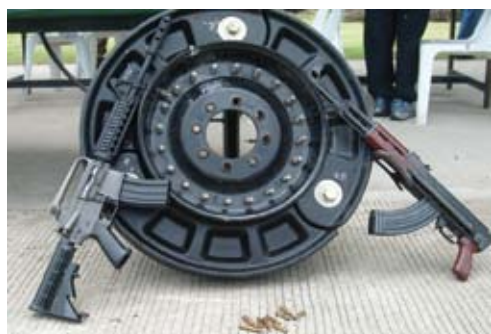
High powered assault rifles

First test was carried out to the Finabel standard, but without the tire fitted. 5 shots into the side of the runflat and 2 into the tread area from 50 meters with an AK47 using 7.62mm bullets and an M16 using 5.56mm bullets.

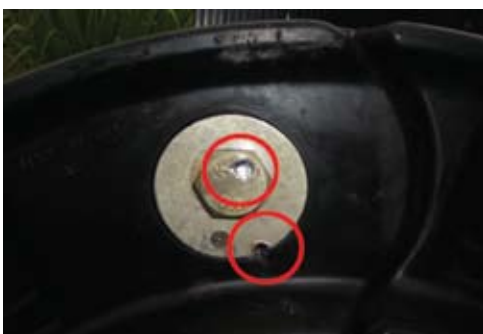
Minimum impact damage to runflat fixings

Special effort was made to hit the fixings with one bullet making a direct hit on the fixing head which ricocheted off and another hitting the washer and was absorbed. The

other three simply passed through the rubber system. The two shots into the tread area around the fixings were simply absorbed therefore none of the shooting had any effect on the performance of the runflat system.

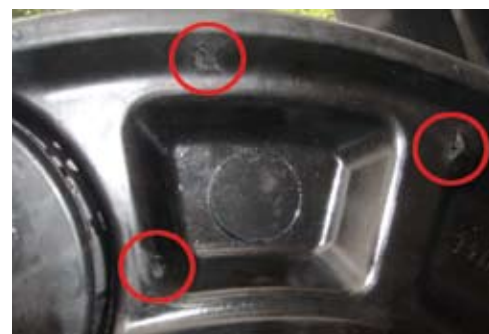
Impact is easily absorbed with no structural breakdown

Even without the added protection of the tire, a total of 35 direct hits on the runflat all aimed at and around the fixings were simply absorbed.
